HOUSATONIC RIVER BASIN

DANBURY, CONNECTICUT

LOWER KOHANZA DAM CT 00064

PHASE I INSPECTION REPORT NATIONAL DAM INSPECTION PROGRAM

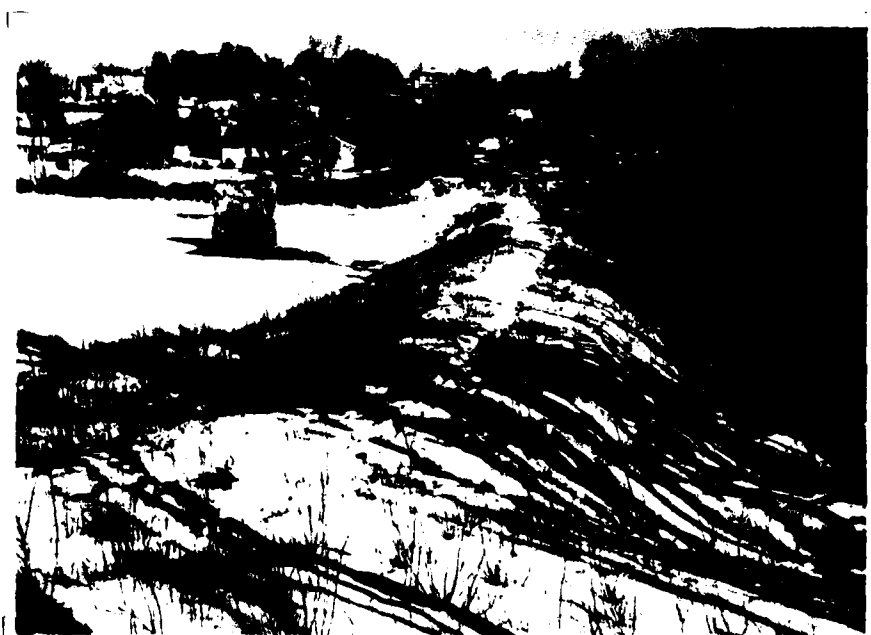
Photo 2. Top and slopes of embankment and upper gatehouse.

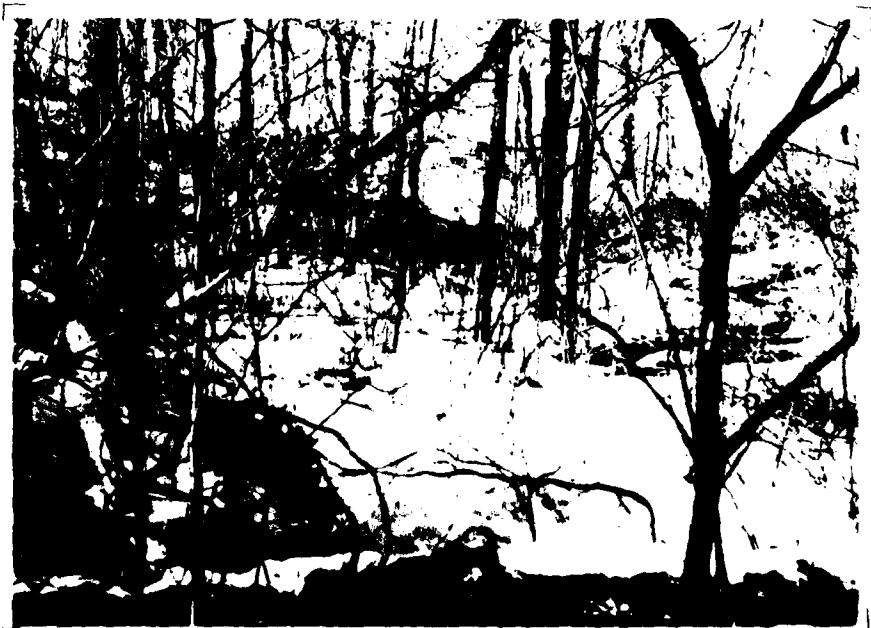
connecting these two structures (Photo 5). A small immeasurable quantity of seepage was also noted at the toe of the dam approximately 90 feet from the right abutment. The seepage flows on the left side of the dam and from between the pumphouse and lower gatehouse have deposited, to varying degrees, a fine brown residue on the downstream toe of the dam (Photo 5). However, the seepage flow observed at the toe of the dam in the vicinity of the right abutment was relatively clear (see Appendix C, pg. C-1, Photo Location Plan for the location of all seepage flows).

Photo 6. Left and right seepage streams at toe of embankment.

- (6) Establish a program to monitor the seepage flows on the downstream toe of the dam on a weekly basis. In addition, a follow-up investigation should be conducted to accurately define the cause of the seepage and the source of the fine brown residue carried by the seepage flows. Upon the completion of this investigation an evaluation of the influence of the seepage on the structural stability of the dam should be conducted. If warranted remedies for this situation should be formulated and instituted.

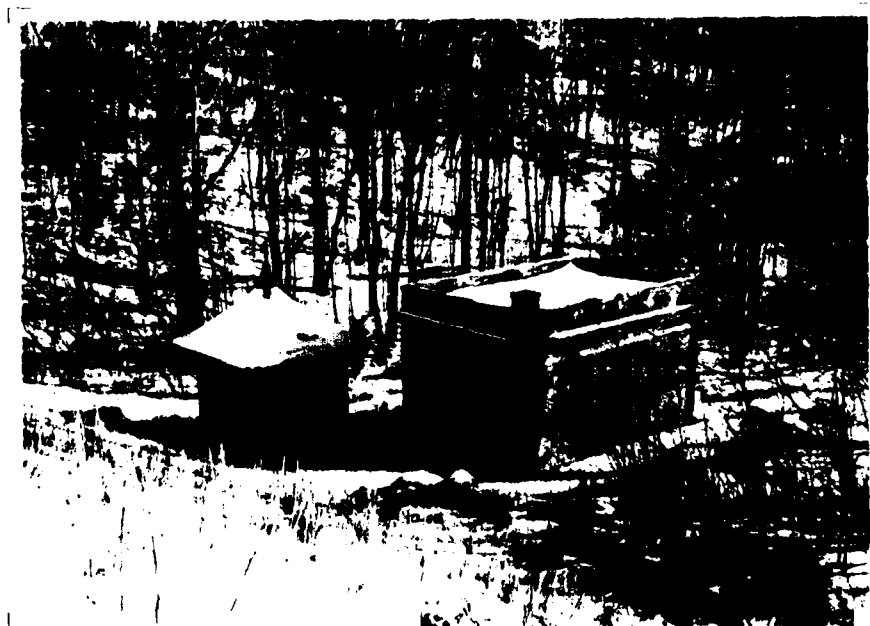
Photo 10. Masonry lower gatehouse and brick pump house at toe of embankment.
